**Flood Control Project Maintenance
Levee Inspections**

Fall 2013 Levee Maintenance Deficiency Summary Report

Reclamation District No. 1500 Sutter Basin

Waterway	Bank	Unit Miles
Unit No. 01 Sacramento River	Left	33.58

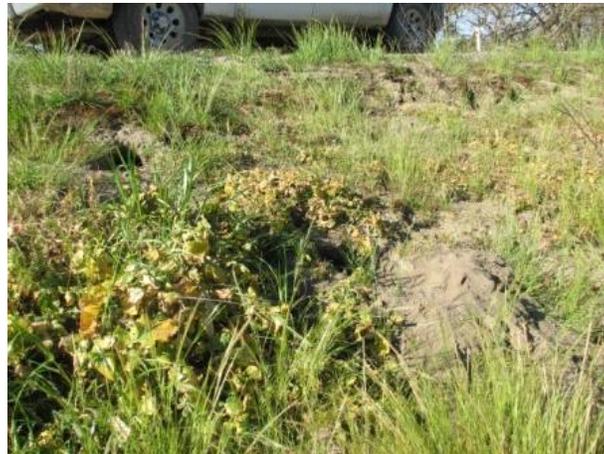
Levee Mile Report Line	5
Start Levee Mile	0.03
End Levee Mile	0.03
Location	Land Side
Category	Earthen Levee
Item	Animal Control
There are many rodent holes a short distance away from the last photo.	
johngw_f_20130924_388.jpg

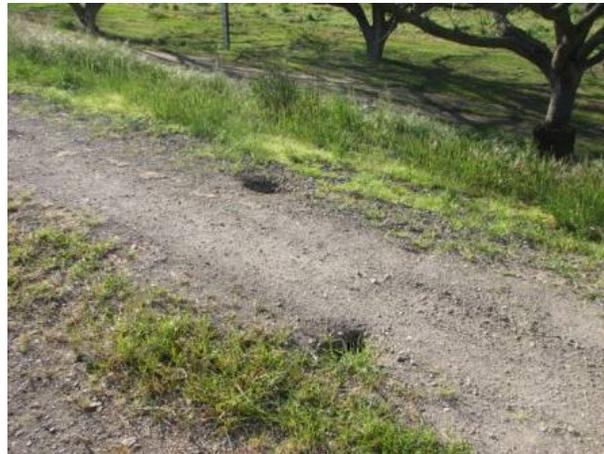
Levee Mile Report Line	7
Start Levee Mile	0.05
End Levee Mile	0.05
Location	Land Side
Category	Earthen Levee
Item	Animal Control
Many rodent holes and a large one that a dog has enlarged Spring 2013	
johngw_f_20130924_451.JPG

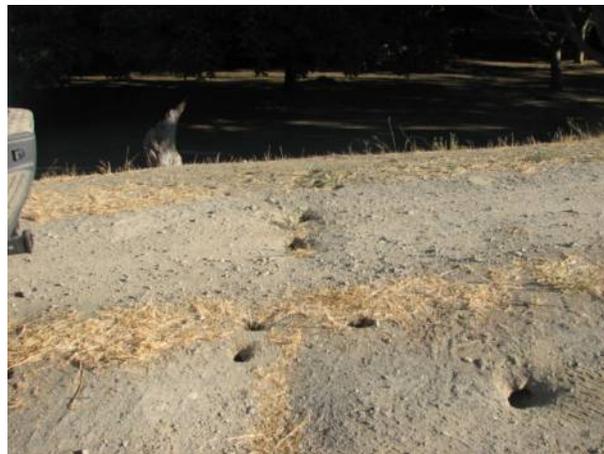
Levee Mile Report Line	9
Start Levee Mile	0.10
End Levee Mile	0.10
Location	Water Side
Category	Earthen Levee
Item	Animal Control
<p>Rodent holes along the levee shoulder. Photo fall 2012.</p>	
<p>johngw_f_20130924_489.jpg</p>

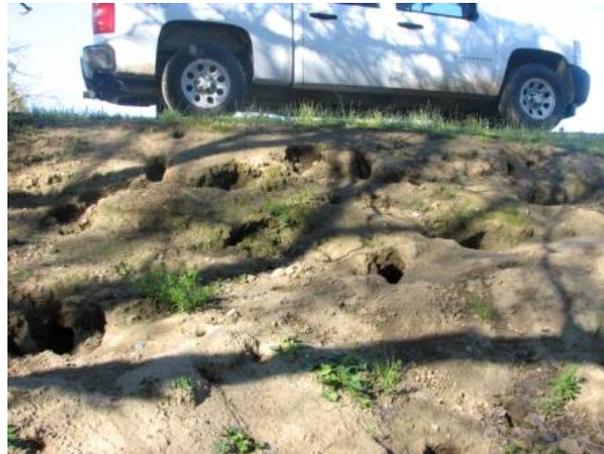
Levee Mile Report Line	11
Start Levee Mile	0.30
End Levee Mile	0.30
Location	Land Side
Category	Earthen Levee
Item	Animal Control
Many rodent holes in a small area. Photo fall 2012.	
johngw_f_20130924_460.jpg

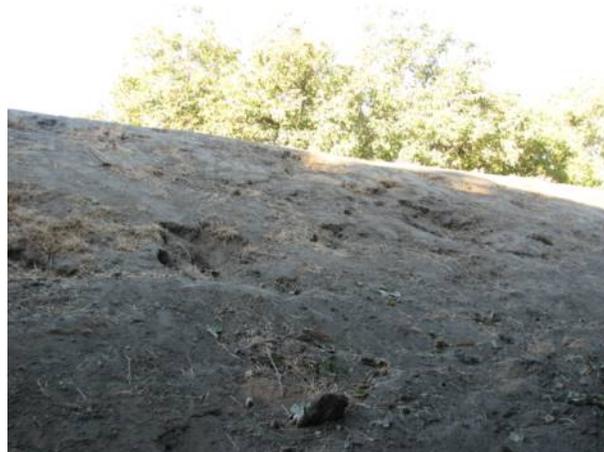
Levee Mile Report Line	11
Start Levee Mile	0.30
End Levee Mile	0.30
Location	Land Side
Category	Earthen Levee
Item	Animal Control
Rodent hole and damage from the on the levee slope. Photo fall 2012.	
johngw_f_20130924_461.jpg

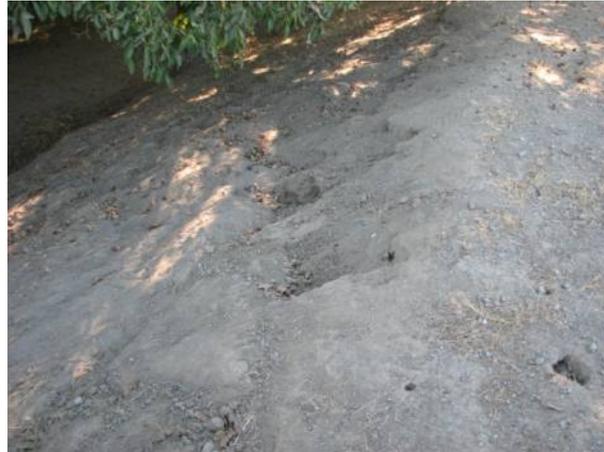
Levee Mile Report Line	12
Start Levee Mile	0.32
End Levee Mile	0.32
Location	Land Side
Category	Earthen Levee
Item	Encroachments
Steps carved into the levee slope at a pipe crossing. Photo fall 2012.	
johngw_f_20130924_445.jpg

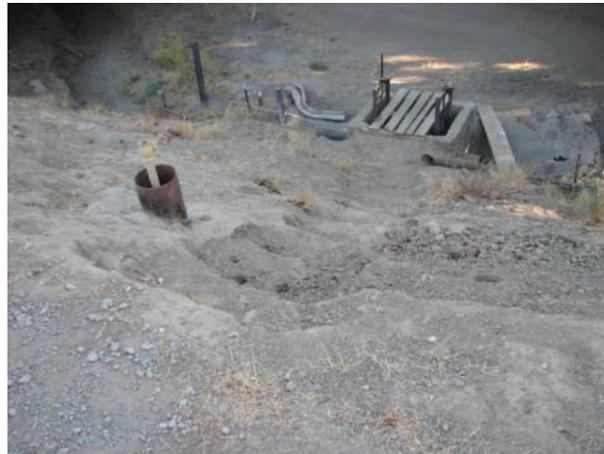
Levee Mile Report Line	15
Start Levee Mile	0.57
End Levee Mile	0.83
Location	Water Side
Category	Earthen Levee
Item	Vegetation
A revegetation site waterside toe, photo taken spring 2012.	
johngw_f_20130924_462.jpg

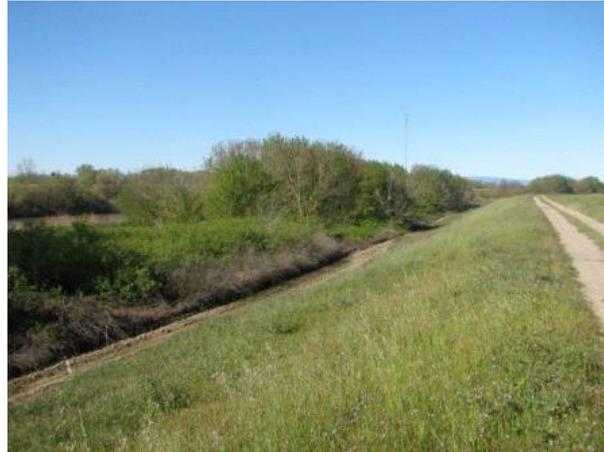
Levee Mile Report Line	16
Start Levee Mile	0.64
End Levee Mile	1.06
Location	Land Side
Category	Earthen Levee
Item	Underseepage Relief Wells

Damage to the seepage berm during the flood season needs to be repaired, Spring 2013

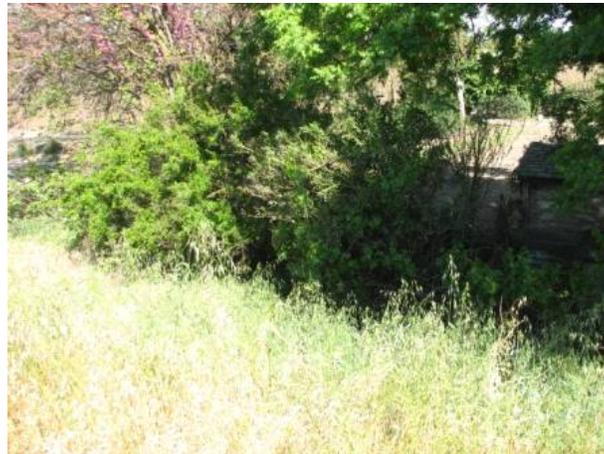
Levee Mile Report Line	28
Start Levee Mile	5.38
End Levee Mile	5.38
Location	Land Side
Category	Earthen Levee
Item	Vegetation
The landscape completely blocks the landside slope and toe.	
johngw_f_20130924_381.jpg

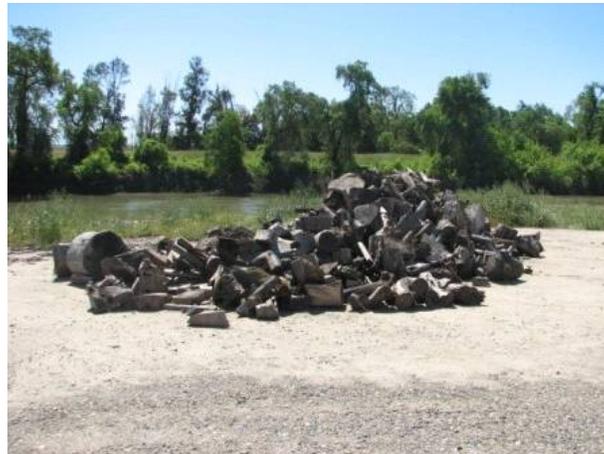
Levee Mile Report Line	54
Start Levee Mile	14.13
End Levee Mile	14.13
Location	Water Side
Category	Earthen Levee
Item	Encroachments
View of equipment. Photo was taken in spring 2010.	
johngw_f_20130924_397.jpg

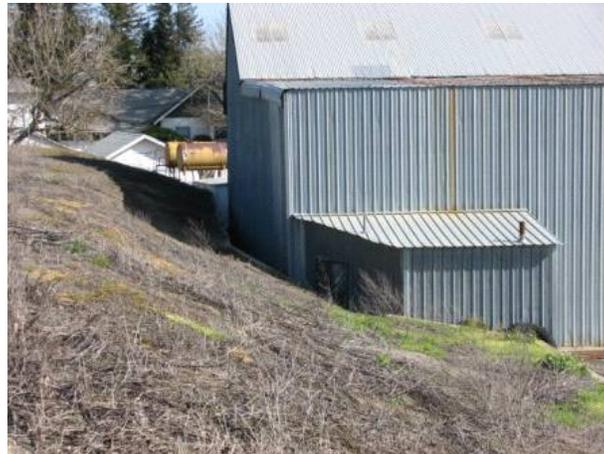
Levee Mile Report Line	57
Start Levee Mile	14.39
End Levee Mile	14.39
Location	Land Side
Category	Earthen Levee
Item	Vegetation
Landscape shrubs on shoulder. Photo was taken in spring 2010.	
johngw_f_20130924_403.jpg

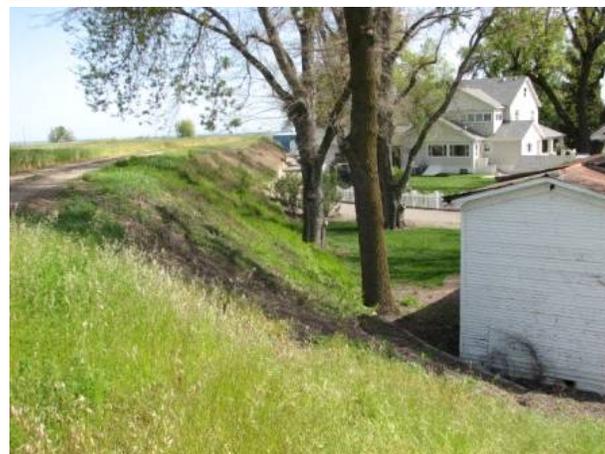
Levee Mile Report Line	71
Start Levee Mile	19.22
End Levee Mile	19.22
Location	Land Side
Category	Earthen Levee
Item	Vegetation
The groundcover is on the levee slope above the concrete retaining wall. The groundcover is irrigated.	
johngw_f_20130924_413.jpg
